FIRST ENDORSEMENT on NAS Los Alamitos Aircraft Accident Report, serial 3-68A, concerning A-4A, BuNo 137828 accident occurring on 17 April 1968, pilot SHAFER

OPNAV REPORT 3750-1

NAS LOS ALAMITOS 3-68A, 4-17-68

INVESTIGATION OF J65-WIGA ENGINE 617041 FROM A-4A BUNO 137828

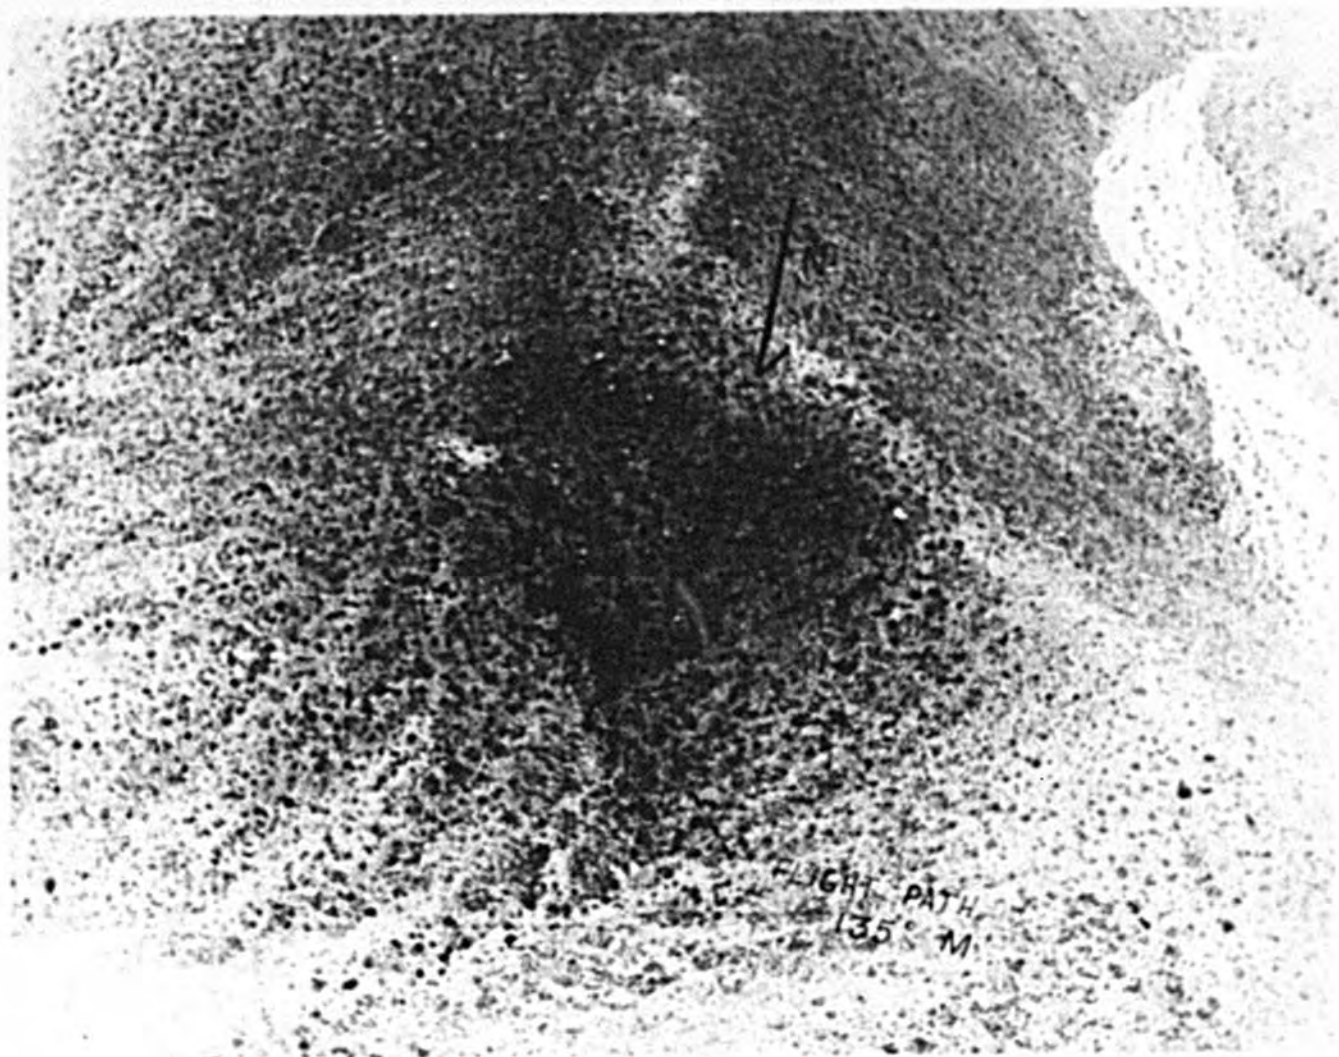
B. Upon impact, the aircraft gouged the rocky terrain to a depth of approximately three to four feet for a distance of about 20 to 30 feet. The aircraft exploded and disintegrated, scattering fuel and debris throughout an area approximately 300 feet laterally and 500 feet upslope from the point of initial impact. There was little ground fire, due to the lack of foliage in the area.

C. The aircraft crashed on a heading of approximately 135 degrees magnetic. The right main gear strut remained near the right edge of the initial impact area. The turbine section of the engine came to rest about 75 feet upslope from the initial impact point. The tail cone and horizontal stabilizer pieces were found approximately 100 feet beyond the turbine section of the engine. The compressor section of the engine was located approximately 100 feet beyond the tail cone and horizontal stabilizer.

ENCLOSURE (4) 1-IMPACT POINT, 2-TURBINE, 3-HORIZONTAL STABILIZER,
4-COMPRESSOR SECTION.

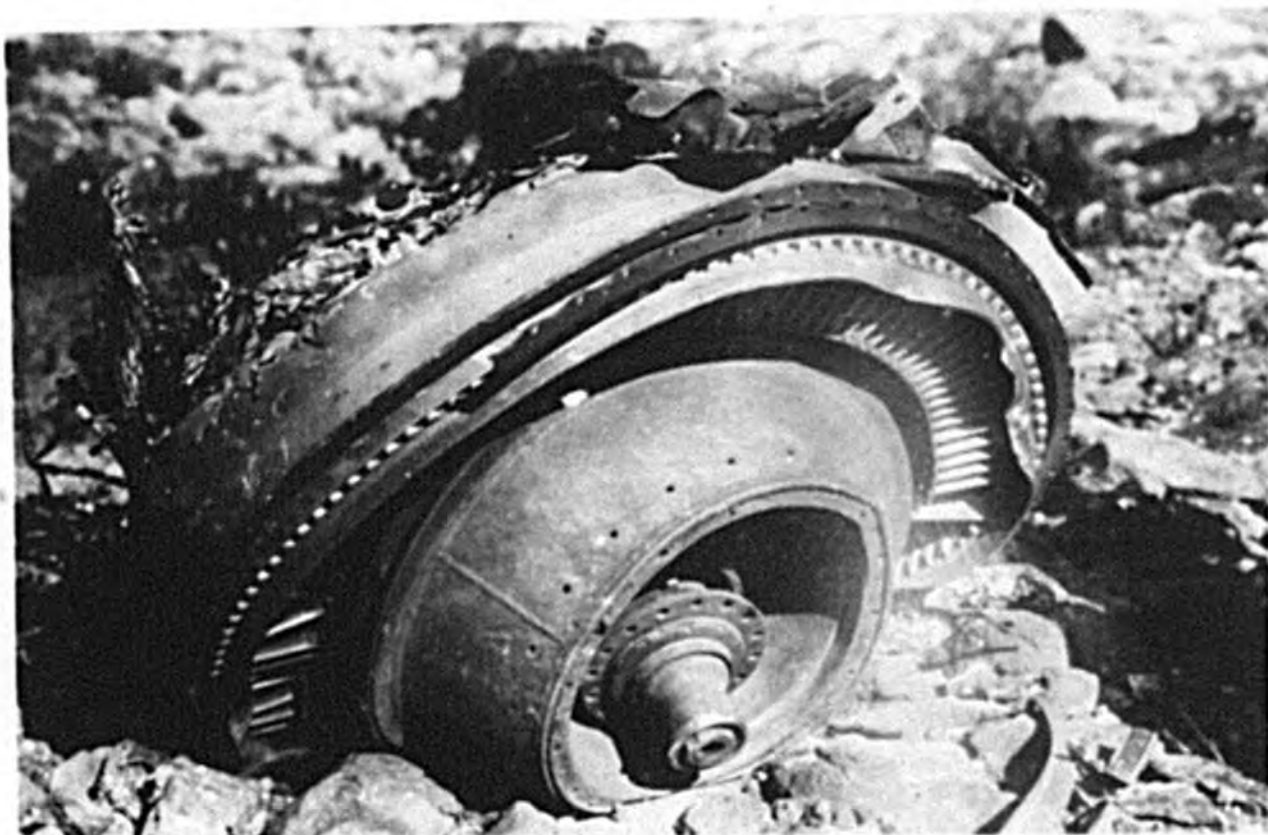
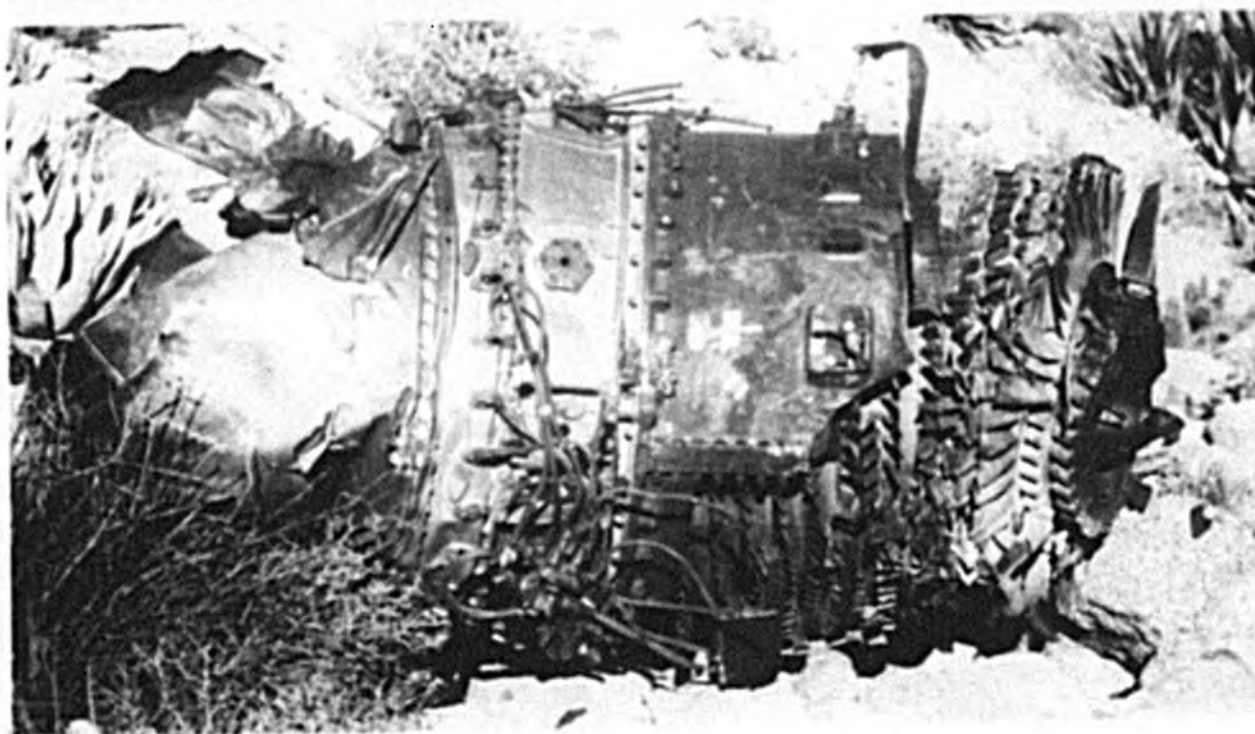
ENCLOSURE (5) COMPOSITE VIEW OF ENGINE AND TURBINE AS FOUND AT CRASH SITE.
 NAS LOS ALAMITOS 3-68A, 4-17-68
 A-4A, BUNO 137828, pilot (b) (6) VA-773
 SPECIAL HANDLING REQUIRED LAW OPNAVINST 3750.6 SE 2S

1. ENGINE COMPRESSOR AND TURBINE SECTION HAVE SEVERE EVIDENCE OF
IN-FLIGHT FAILURE AND DAMAGE.

2. ENGINE SEVERELY DAMAGED AT IMPACT. EVIDENCE OF VERY LOW RPM AT
TIME OF IMPACT.

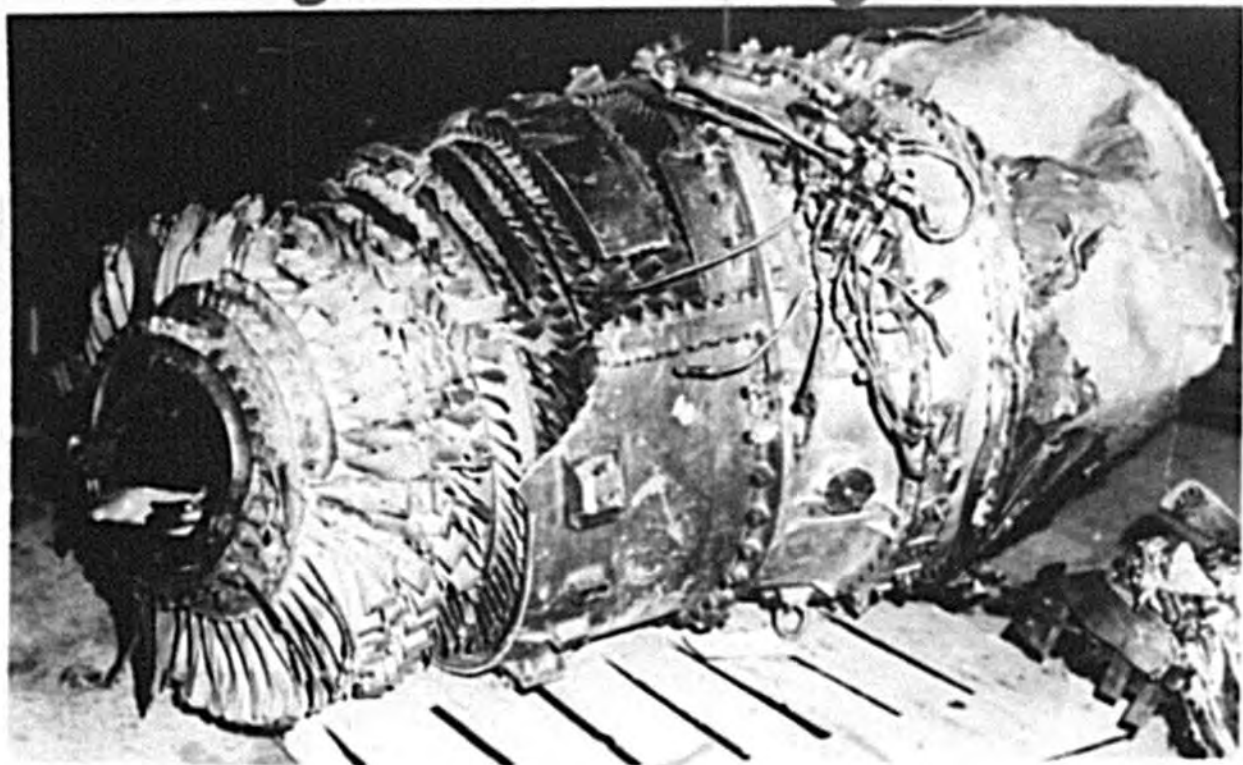
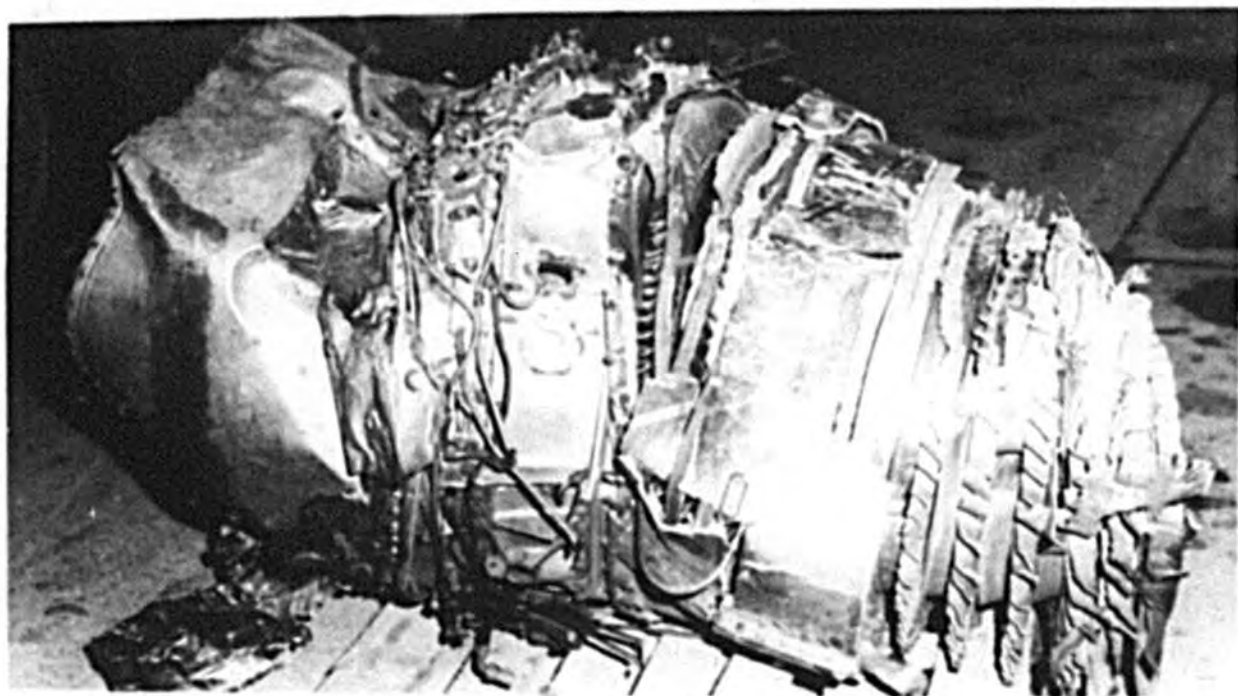
ENCLOSURE (6) COMPOSITE PHOTO OF ENGINE COMPRESSOR SECTION.
 NAS LOS ALAMITOS 3-68A, 4-17-68
 A-4A, BUNO 137828, pilot (b) (6) VA-773
 SPECIAL HANDLING REQUIRED IAW OPNAVINST 3750.6 SERIES

5. FOURTH, FIFTH, SIXTH, AND SEVENTH STAGE COMPRESSOR ROTOR BLADES
DAMAGED AND BROKEN. APPROX 20 BLADES IN EACH STAGE BROKE AT THE PLATFORM.
BELIEVED CAUSED BY IMPACT.

6. EIGHTH THRU THIRTEENTH STAGE COMPRESSOR ROTOR BLADES SEVERELY
DAMAGED.

10. LESS THAN ONE-THIRD OF COMPRESSOR CASE WAS RECOVERED. MOSTLY REAR
PORTION. SCATTERED QUANTITIES OF AFT COMPRESSOR STATOR VANES RECOVERED.

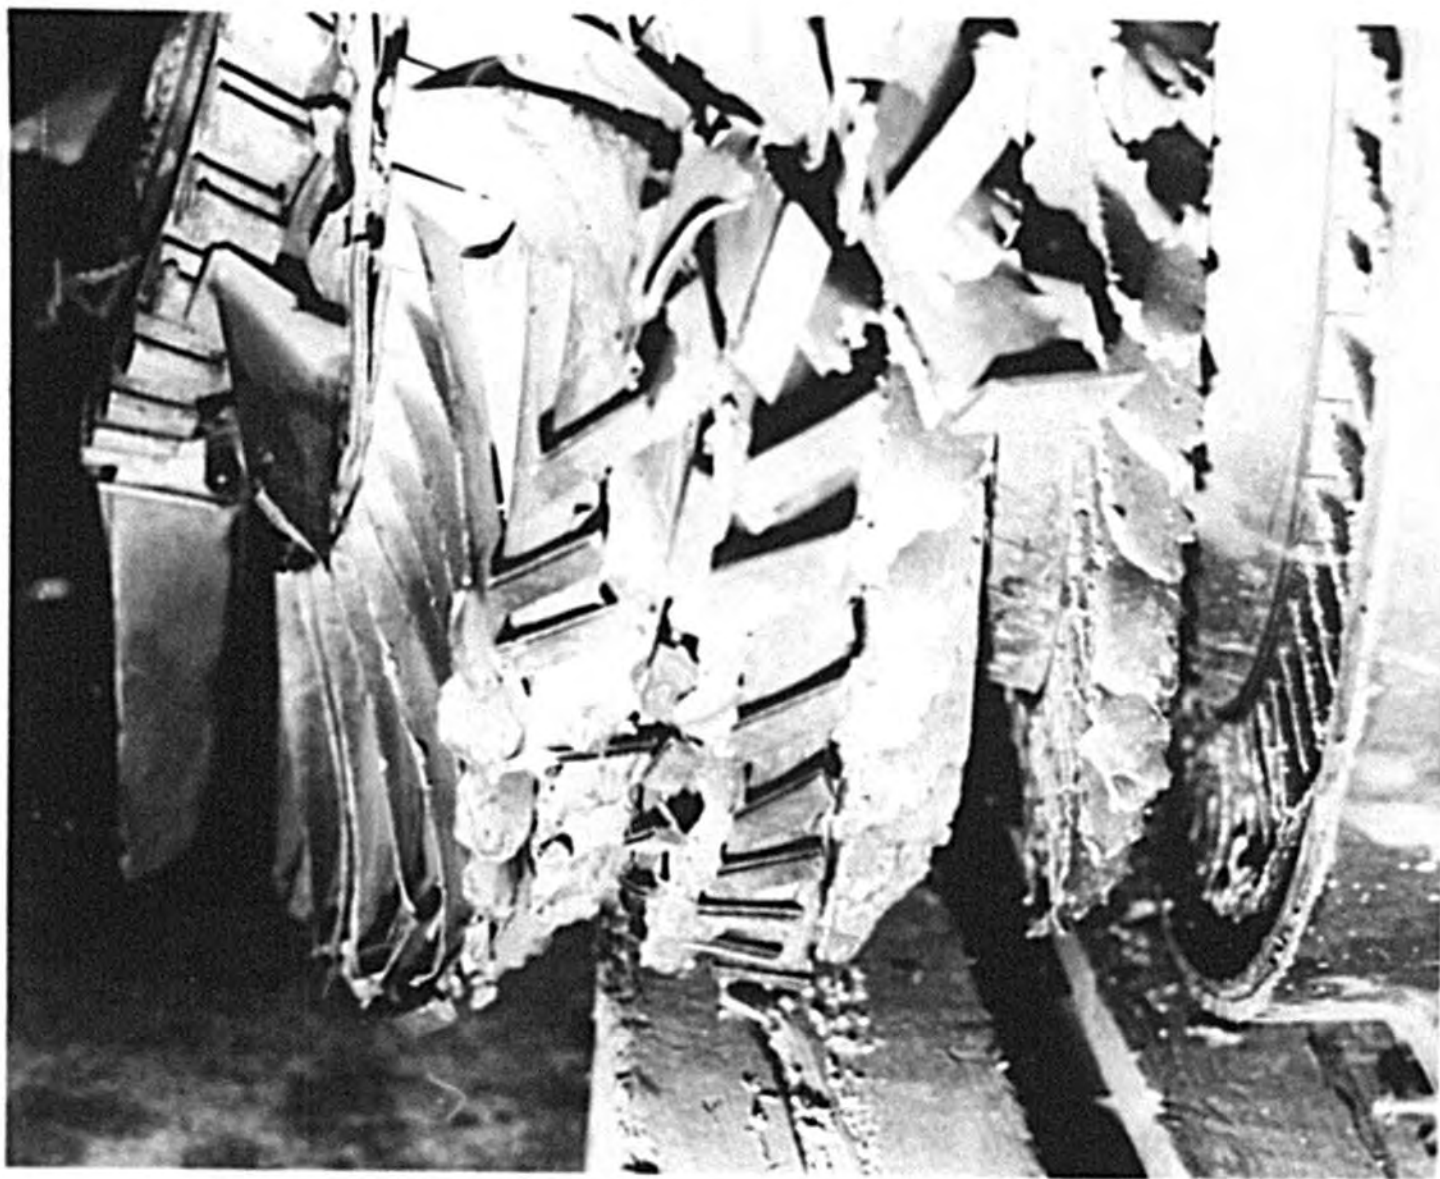
ENCLOSURE (7) 1st STAGE COMPRESSOR BLADE SUSPECTED OF FAILURE
NAS LOS ALAMITOS 3-68A, 4-17-68
A-4A, BUNO 137828, pilot (b) (6) VA-773
SPECIAL HANDLING REQUIRED IAW OPNAVINST 3750.6 SERIES

3. RECOVERED ALL BUT NINE FIRST STAGE COMPRESSOR ROTOR BLADES 231817
(J65 PPC 26). ALL BLADES SHOW ROTATIONAL AND IMPACT DAMAGE. TWO FIRST
STAGE BLADES HAD BLADE TIP BROKEN OFF APPROX 3 1/4 INCHES ABOVE BLADE
PLATFORM. BLADE TIPS NOT RECOVERED. ONE BLADE EXHIBITS A POSSIBLE
FATIGUE CONDITION. CAUSE OF THIS CONDITION UNDETERMINED. BROKEN BLADE
WITH FATIGUE INDICATIONS FORWARDED TO CURTISS WRIGHT SERVICE ENGINEERING
VIA LOREP. CURTISS WRIGHT AGREED TO FURTHER METALLURGICAL STUDY OF
BROKEN BLADE. FIRST STAGE BLADES HAVE A TOTAL OPERATING TIME OF 63.1
HOURS.

15. CONCLUDE THAT REPORTED IN-FLIGHT EXPLOSION ORIGINATED IN FRONT OF
COMPRESSOR IN AREA OF INLET GUIDE VANE AND FIRST STAGE COMPRESSOR ROTOR.
CAUSE OF COMPRESSOR FAILURE UNDETERMINED. THREE POSSIBLE CAUSES ARE
FOREIGN OBJECT DAMAGE, INLET GUIDE VANE OR CARRIER WING FAILURE, OR
FIRST STAGE COMPRESSOR ROTOR BLADE FAILURE. METALLURGICAL INVESTIGATION
OF BROKEN FIRST STAGE COMPRESSOR ROTOR BLADE AT CURTISS WRIGHT MAY
ASSIST IN MORE POSITIVE CONCLUSIONS.

14. IAW REF D RECOMMEND NAVAIRSYSCOM TECH REP WOODRIDGE TAKE PARAGRAPH
THREE FOR ACTION. CONDUCT METALLURGICAL STUDY OF BROKEN BLADE WITH
FATIGUE CONDITIONS. UPON COMPLETION NOTIFY ALCON RESULTS OF FINDINGS
UNDER YOUR CONTROL 2614-68. FORWARD BROKEN BLADE AND ANY BLADE
SPECIMENS TO NAVAIRNSAFECEN NORVA. ACCIDENT INVESTIGATION DIVISION,
ATTENTION MR. (b) (6)

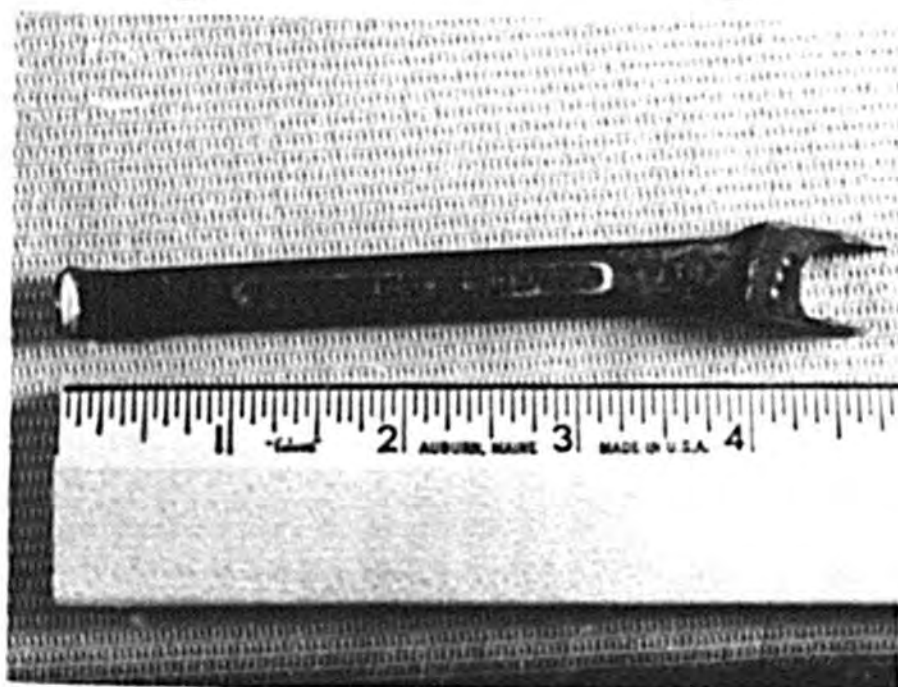
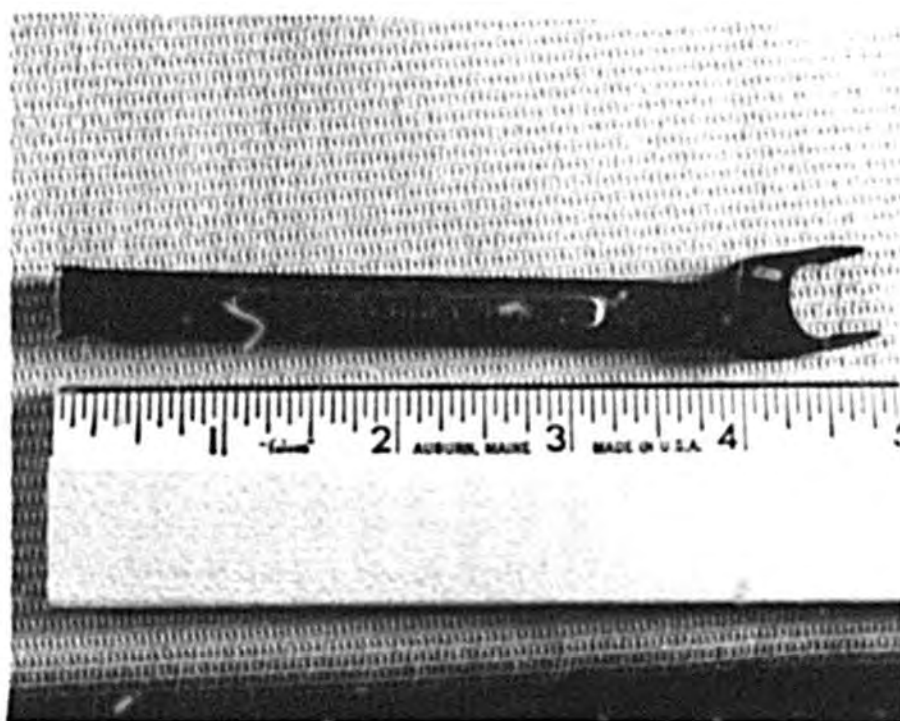
ENCLOSURE (10) WRENCH FOUND AT IMPACT POINT
NAS LOS ALAMITOS 3-68A, 4-17-68
A-1A, BUNO 137828, PILOT (b) (6)
SPECIAL HANDLING REQUIRED IAW OPNAVINST 3750.6 SERIES
